From: Donald Hartley <dhartley@utah.gov>
Sent: Wednesday, April 4, 2018 5:33 PM
To: Shayne Scott <sscott@kaysvillecity.com>
Cc: Roger Roper <rroper@utah.gov>; Katie Witt <mayor.witt@kaysvillecity.com>; Mike Blackham <blackham@KaysvilleCity.com>; Cole Stephens <cstephens@kaysvillecity.com>; Michelle Barber <councilmember.barber@kaysvillecity.com>; James C. Hansen <councilmember.hansen@kaysvillecity.com>; galbraithlc@comcast.net
Subject: Re: FW: Old Library - Kaysville

I had a phone conversation with Lynn Galbraith yesterday morning regarding our meeting at the Kaysville old library building (old library) on Tuesday. I want confirm some items from both discussions.

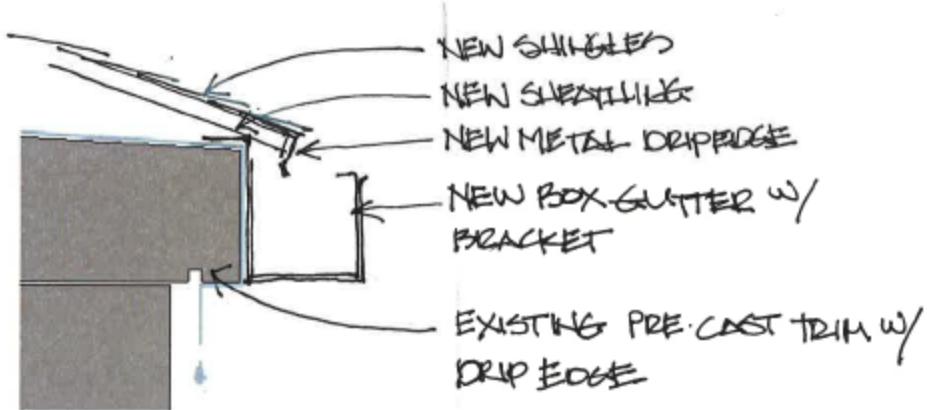
Mike Blackham noted the lack of roof overhang at the eaves. The building was designed without overhanging eaves and no gutters. As a result water run-off from the roof has entered the wall cavities from the eaves. The building was probably built with wood shingles which would have projected a couple of inches beyond the pre-cast concrete trim to form the primary drip edge. The pre-cast trim projects from the wall slightly and has a drip edge cast into the bottom of the overhang to act as a secondary drip edge. Mike recommended extending the eaves if the building is rehabilitated. I agree, but suggest limiting the overhang to only what is necessary to drip into a new box gutter, sized and fabricated to SMACNA standards:
